Final Report

FUEL OIL TANK EMISSIONS TESTING FEASIBILITY STUDY

Battelle
Columbus, OH

Eastern Research Group, Inc.
Austin, TX

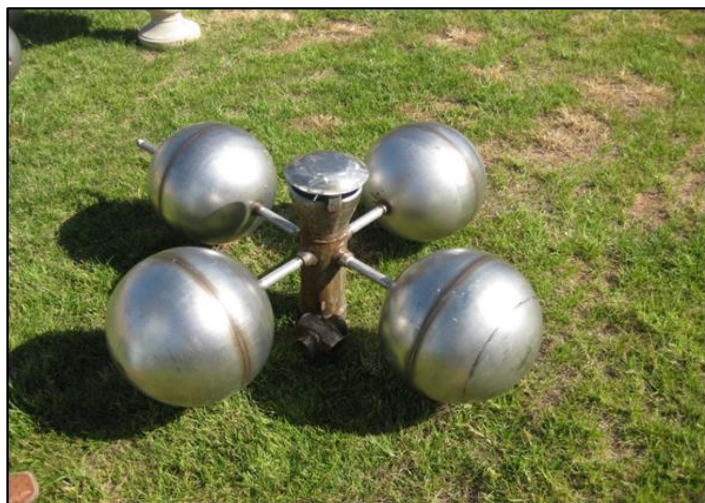
braided stainless steel tubing, the more floats are required. Figure 1 depicts a four float GOST apparatus.

Figure 1. A four-float GOST apparatus.

The GOST apparatus is a vapor recovery device that operates as a float, in the case of the field tested system, inside an unheated atmospheric oil storage tank. When suspended on top of the oil layer in the storage tank, the vapor opening of the GOST apparatus is maintained above the oil layer liquid surface, thereby allowing the collection of vapors from inside the tank. The number of floats required to support the GOST apparatus on the liquid surface depends on the weight of the braided stainless steel tubing used to convey gases from the gas apparatus out of the tank and to the gas recovery system; the greater the weight (i.e., the longer the length) of the

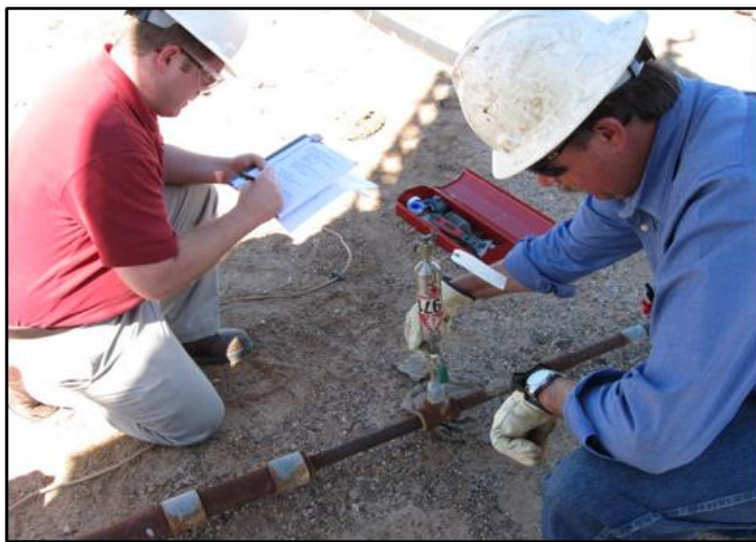
Figure 3. Photograph of sampling point in the vapor recovery line.

When the GOST apparatus was in operation, gas samples were collected from a sampling port located between the gas volume totalizer and the tie-in with the lease's main gas export line. Figure 3 shows this sampling point. In addition, a pair of samples were collected simultaneously from this sampling point and from a sampling point located in a valved overhead line exiting from the unheated atmospheric oil storage tank in which the GOST apparatus was installed.

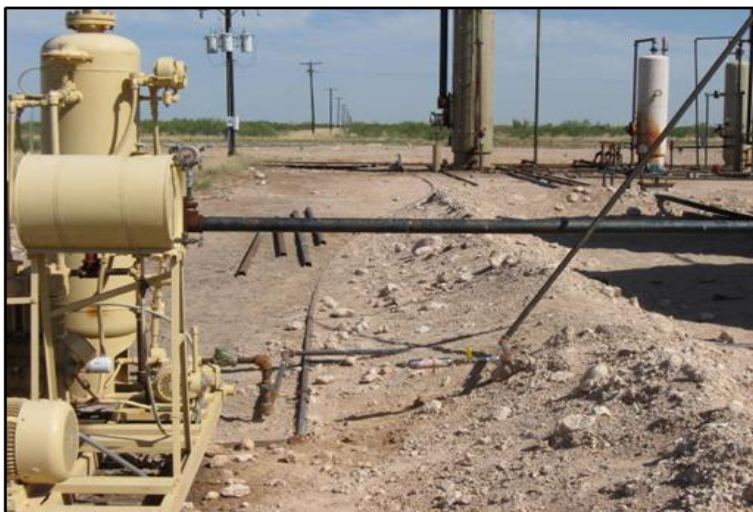
Figure 4. Photograph of sampling point in valved overhead line exiting the storage tank in which the GOST apparatus is installed.

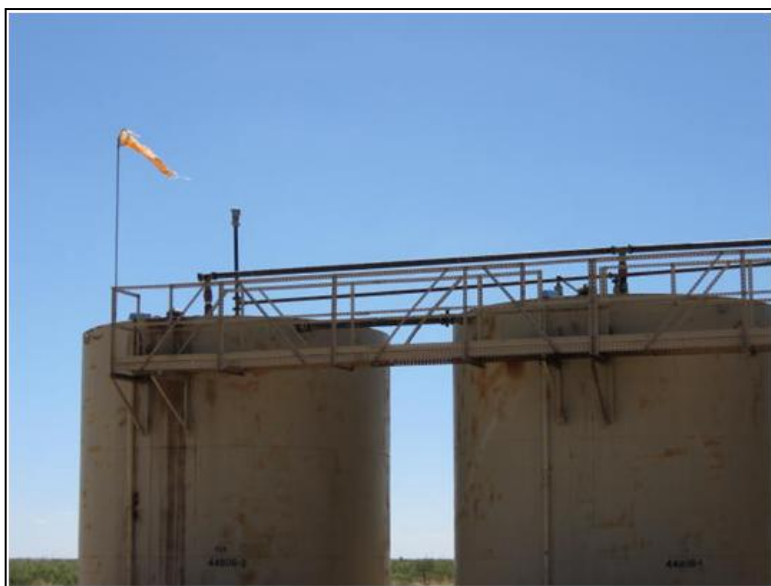
Figure 5. Photograph displaying the view from the FLIR GasFindIR MW camera vantage point on the first day of field testing.

storage tank in which the GOST apparatus is installed (i.e., Tank 2, the center tank in the figure) is not directly viewable, however, the pressure relief valve and the unheated atmospheric oil storage tank which does not have the GOST apparatus installed (Tank 1, the left tank in the figure) are viewable.

On the first day of field testing the field test team set up the FLIR GasFindIR MW camera in a location approximately 72 feet (ft) from the tank battery. This location was chosen because all storage tanks at the tank battery could be viewed such that the wind would carry any organic compound emissions in a direction perpendicular to the camera's field of view (i.e., camera observations were made facing west while the wind at the field site was noted as blowing out of the south-southwest). The viewing background from this location was the sky behind the tank battery. Figure 5 displays the view from the vantage point for camera observation on the first day of field testing. In Figure 5, the unheated atmospheric oil storage tank on the right is the tank in which the GOST apparatus is installed (referred to as Tank 2 in this report) and the tank on the left is the unheated atmospheric oil storage tank that does not have the GOST apparatus installed (referred to as Tank 1 in this report).

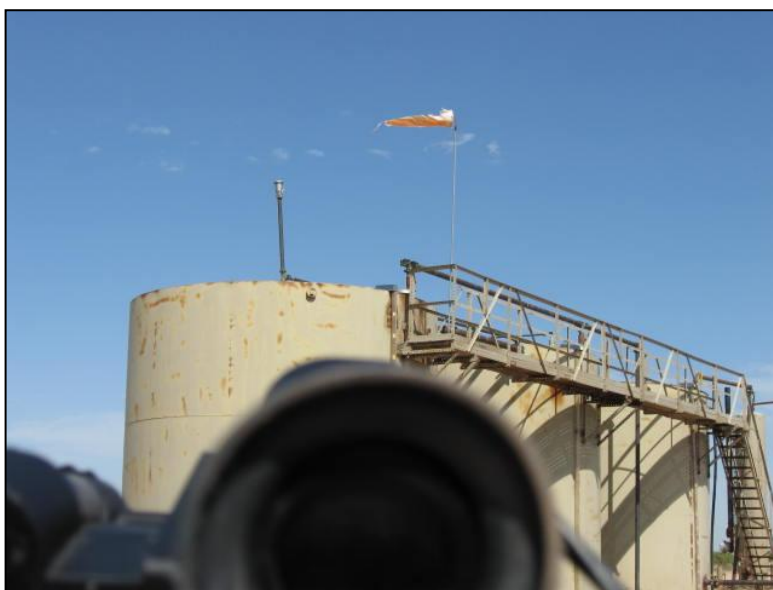
Figure 6. Photograph displaying the view from the FLIR GasFindIR MW camera vantage point on the second day of field testing.
